PANTHER **VS** SHERMAN

Battle of the Bulge 1944

STEVEN J. ZALOGA

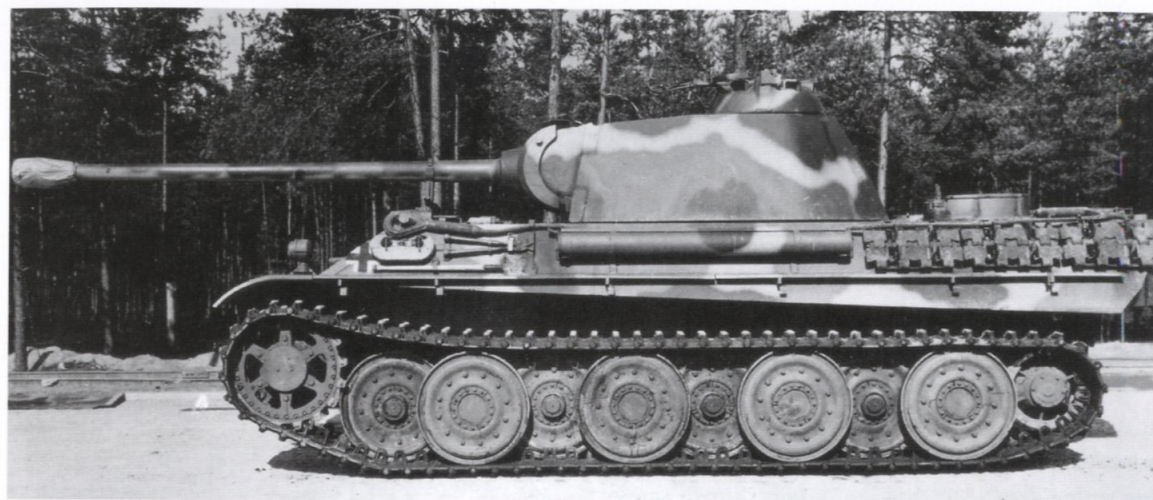
By the time of the Ardennes fighting, the Panther regiments had been reequipped with the new Panther Ausf. G, which featured an improved hull. This is an example from the September 1944 production at MAN in Nuremberg using steel-rimmed road wheels, an uncommon variant of the series. [NARA]

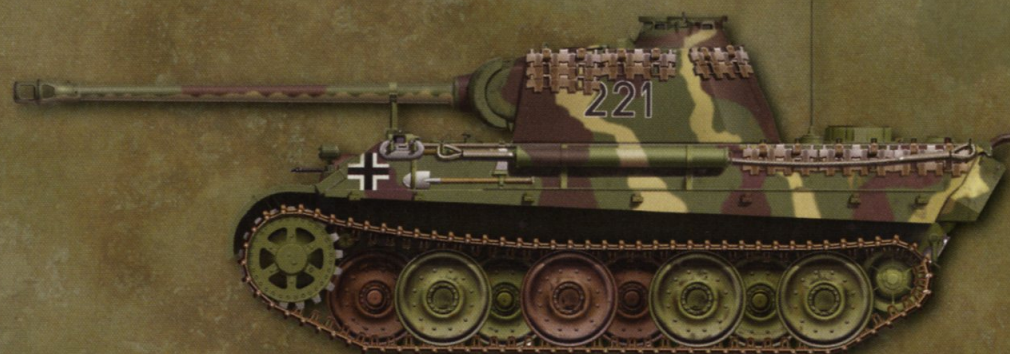
PANTHER SIDE-VIEW

8.6m

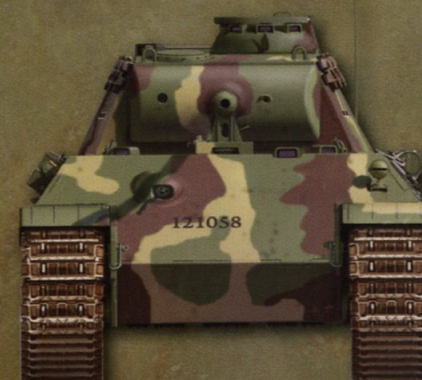
PANTHER FRONT VIEW

3.4m

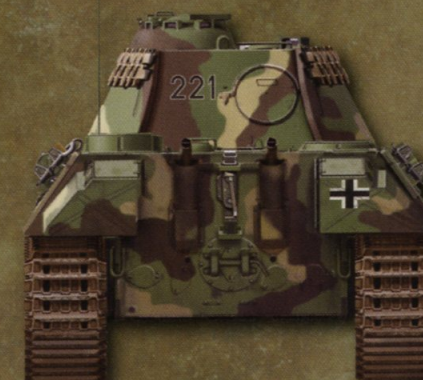
PANTHER REAR VIEW

2.9m

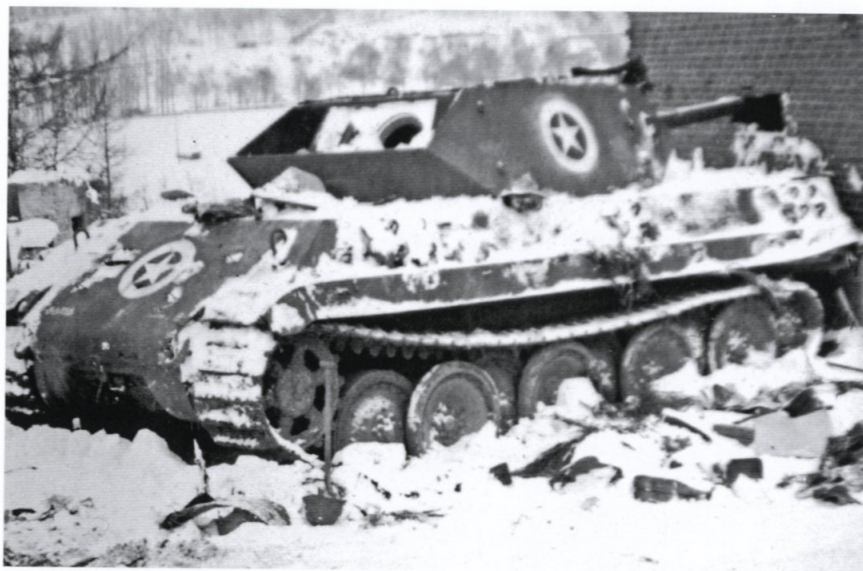
The oddest Panthers fielded in the Ardennes were five that were converted to look like US M10 tank destroyers for use by Skorzeny's Panzer Brigade 150. This was the ersatz M10 of Lt Gerstenschlager, abandoned at the attack on Malmedy on December 21 near the Café du Rocher de Falize. [NARA]

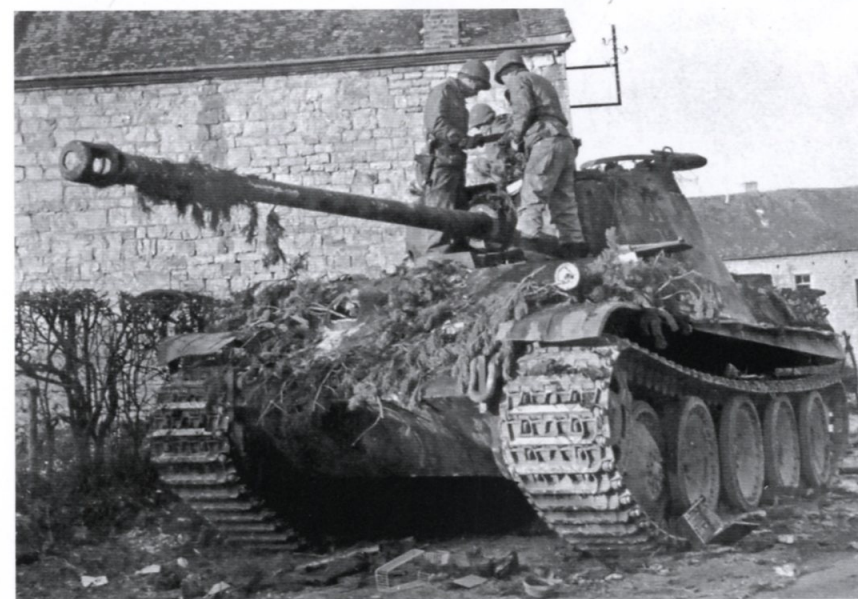
Virtually all the Panthers that saw combat in the Ardennes were newly manufactured from September to November production runs. This is a Panther Ausf. G of the II./Pz.Rgt. 9, 9th Panzer Division being inspected by GIs of the 83rd Division in late December lost during the attempts to rescue the trapped 2nd Panzer Division beyond Bastogne. [NARA]

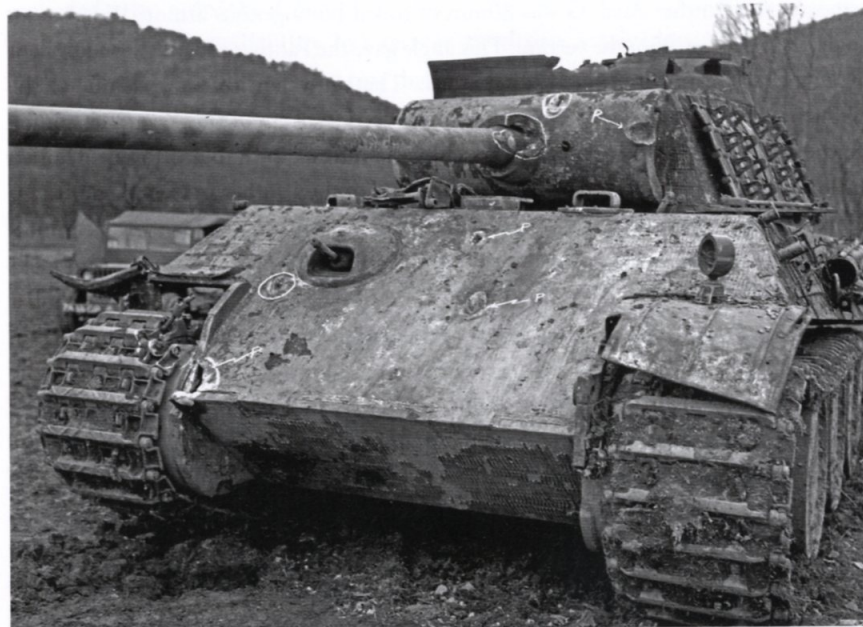
The Panther offered formidable protection against the 76mm, as seen in this test conducted on a captured early production Ausf. G at Saverne, France, in February 1945 by the US Seventh Army. Of the eight hits on the tank, five failed to penetrate. One penetrated the mantlet, one bounced off the bottom of the mantlet into the hull roof, and one cracked the glacis armor at the joint with the lower bow plate. [NARA]

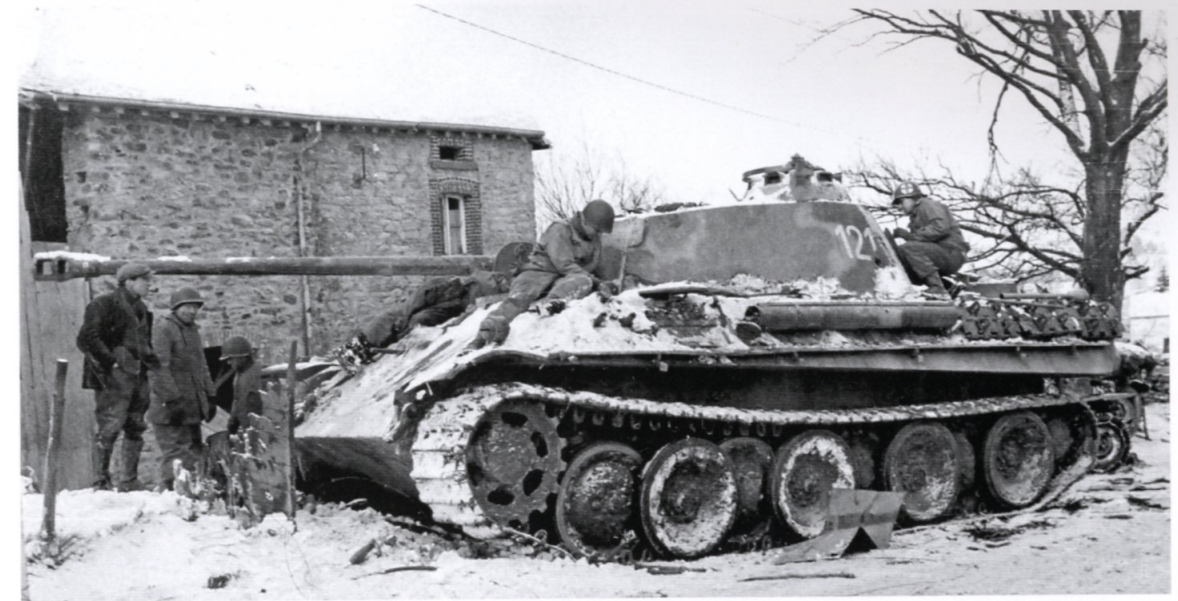
The Panther's side armor remained vulnerable to a wide range of weapons. This Panther Ausf. G, of the 9th SS-Panzer Division, was knocked out by a 57mm antitank gun during the fighting for Langlir, to the northeast of Houfallize, on January 13, 1945. The penetration can be seen on the turret rear at the bottom of the tactical number 121. In the hands of brave crews, the infantry's obsolete 57mm antitank gun remained a major hazard to Panthers in the Ardennes. [NARA]

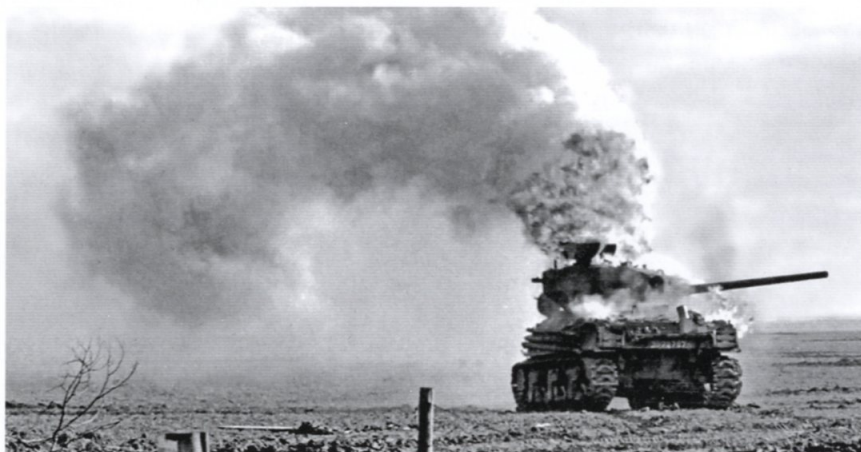
The Sherman had a reputation for vulnerability to fires, wrongly attributed to its gasoline propulsion. German tanks, including the Panther, were gasoline powered, and the real culprit was ammunition propellant as seen in this fire on an M4A1 (76mm) of the 3rd Armored Division in Germany on March 1, 1945. (NARA)

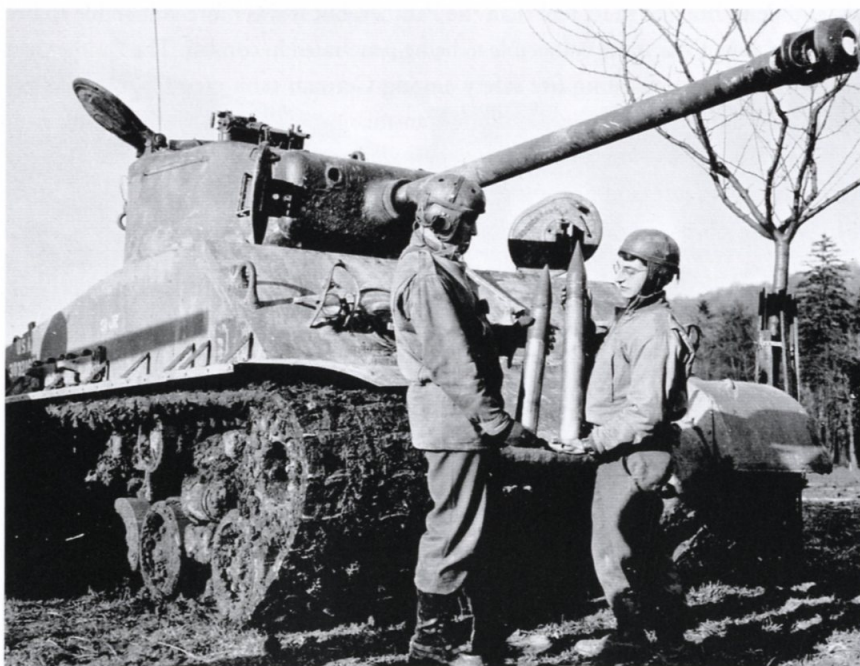
The advent of the 76mm was an improvement in antitank firepower for the Sherman, as can be seen in this comparison of the rounds of the 75mm and 76mm gun in front of this new M4A3E8 of the 2nd Armored Division. (NARA)

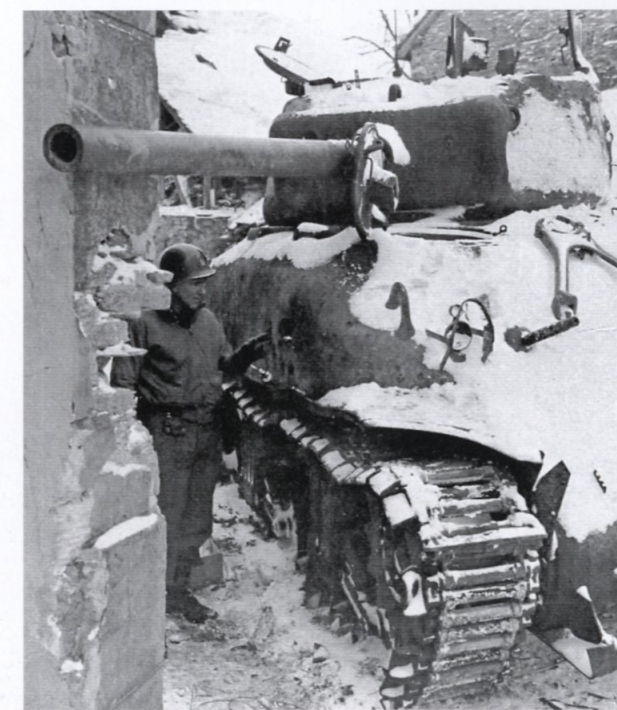
The Sherman was prone to fire because it was vulnerable to penetration by nearly any of the Wehrmacht's antiarmor weapons from the infantry's panzerfaust through the 75mm and 88mm tank and antitank guns. Here the captain points to a penetration in the side hull of an M4A1 (76mm) of the 32nd Armored Regiment, 3rd Armored Division, which led to a catastrophic fire that burned the rubber off the tracks and wheels. This is an old Normandy veteran, with bits of the Douglas bocage cutter still evident on the bottom of the differential cover. (NARA)

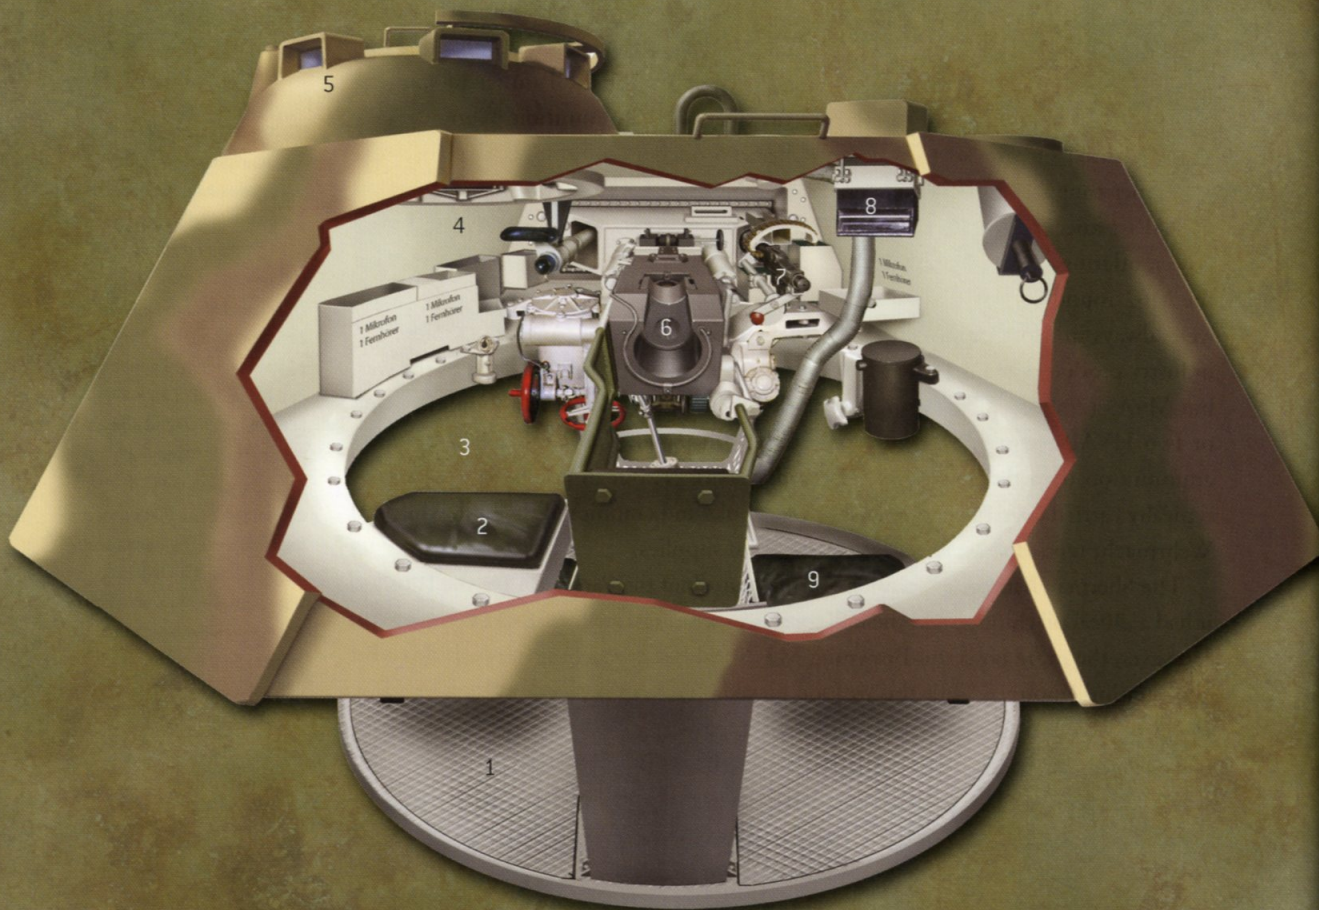
PANTHER TURRET

1. Sprenggranaten 42 (HE)
2. Panzergranate 39/42 (AP)

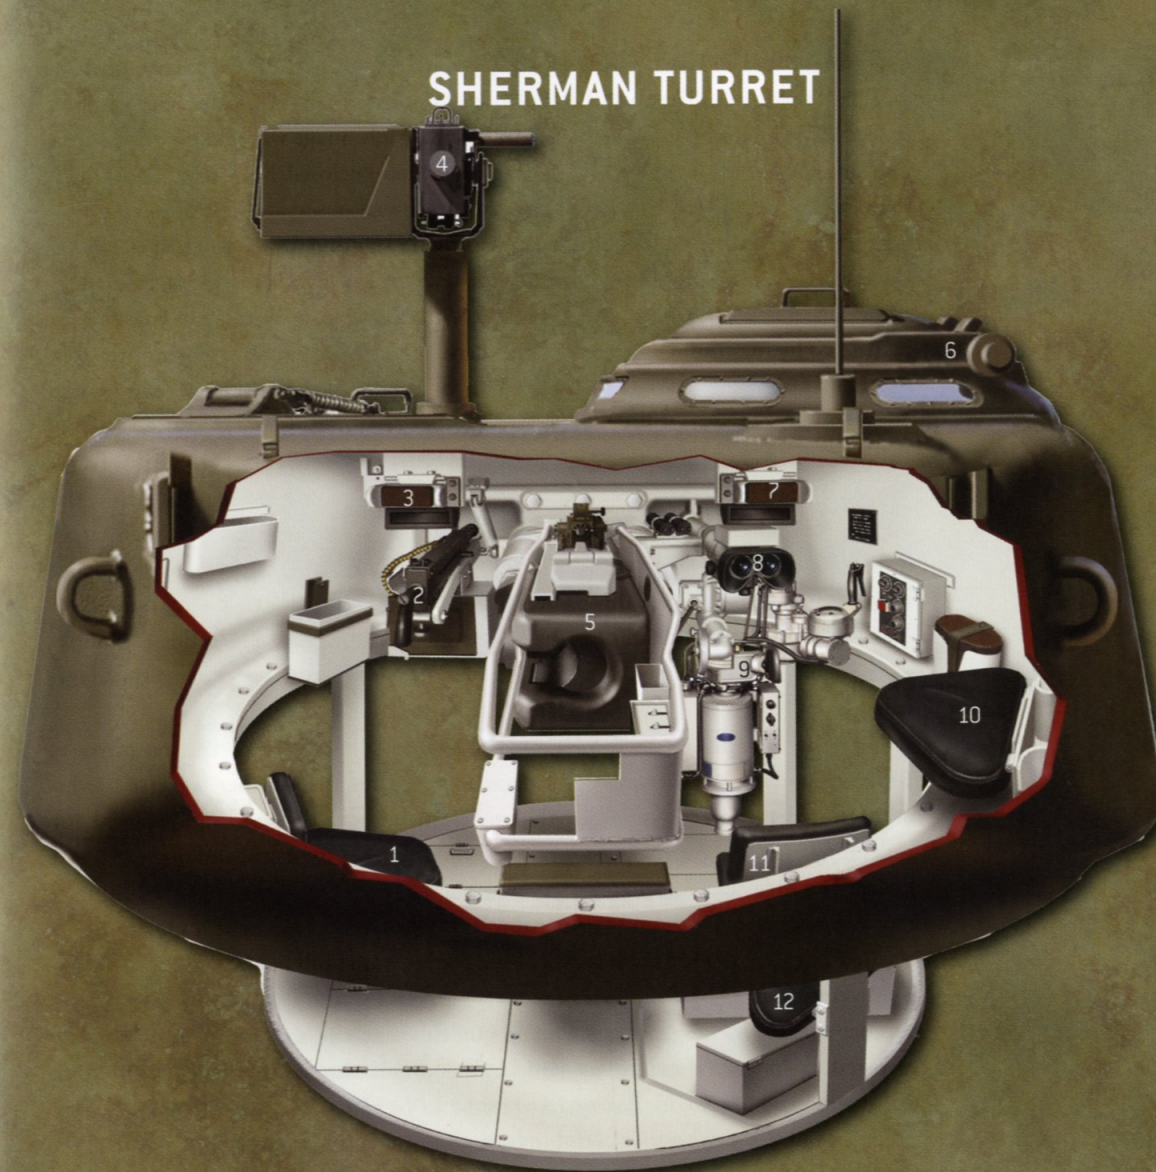
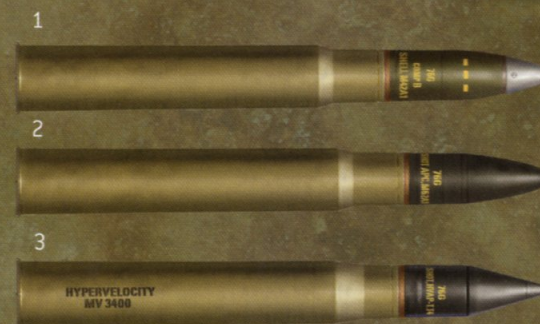
1. M42A1
2. Armor Piercing Capped (APC), M62A1
3. High Velocity Armor Piercing (HVAP)

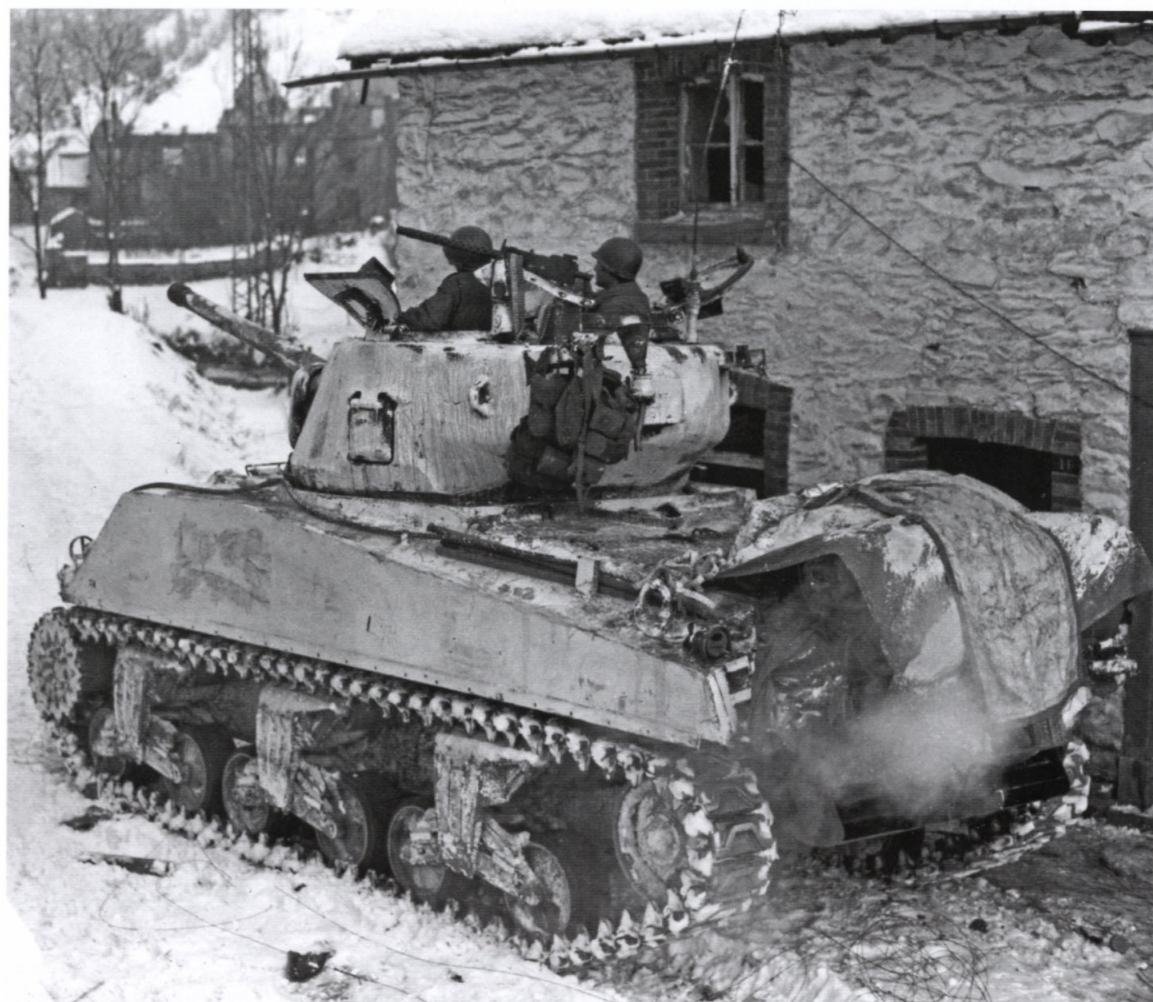
A M4A3 (76mm) of the 750th Tank Battalion moves into Salmchateau in support of the 75th Division on January 16, 1945. The track is fitted with "duckbill," extended end connectors to improve flotation in mud.

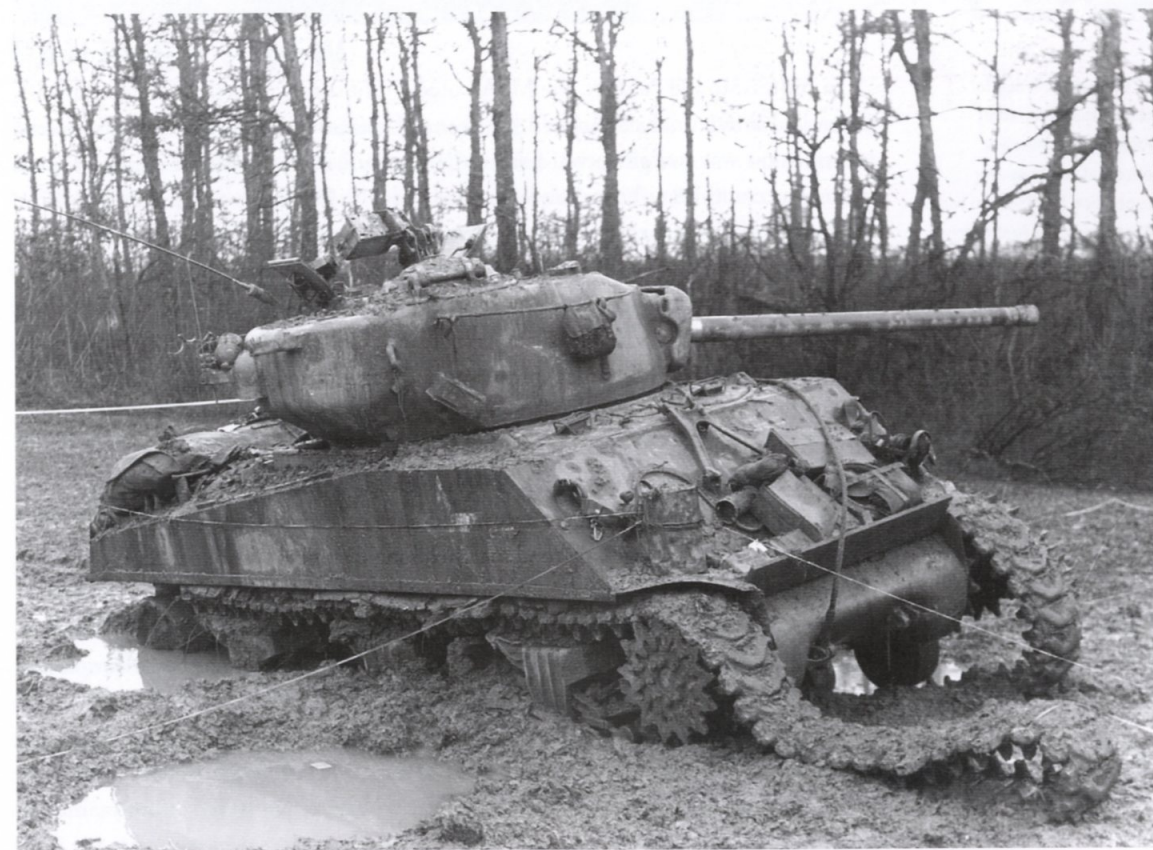
Mud was a bane to both US and German forces in autumn 1944 due to exceptionally heavy rainfall. This M4A3 of the 6th Armored Division fell victim to the mud and mines on November 25, 1944. The adoption of "duckbill" extended end connectors to the tracks improved, but did not eliminate, the problem, giving the M4A3 flotation comparable to the Panther. (NARA)

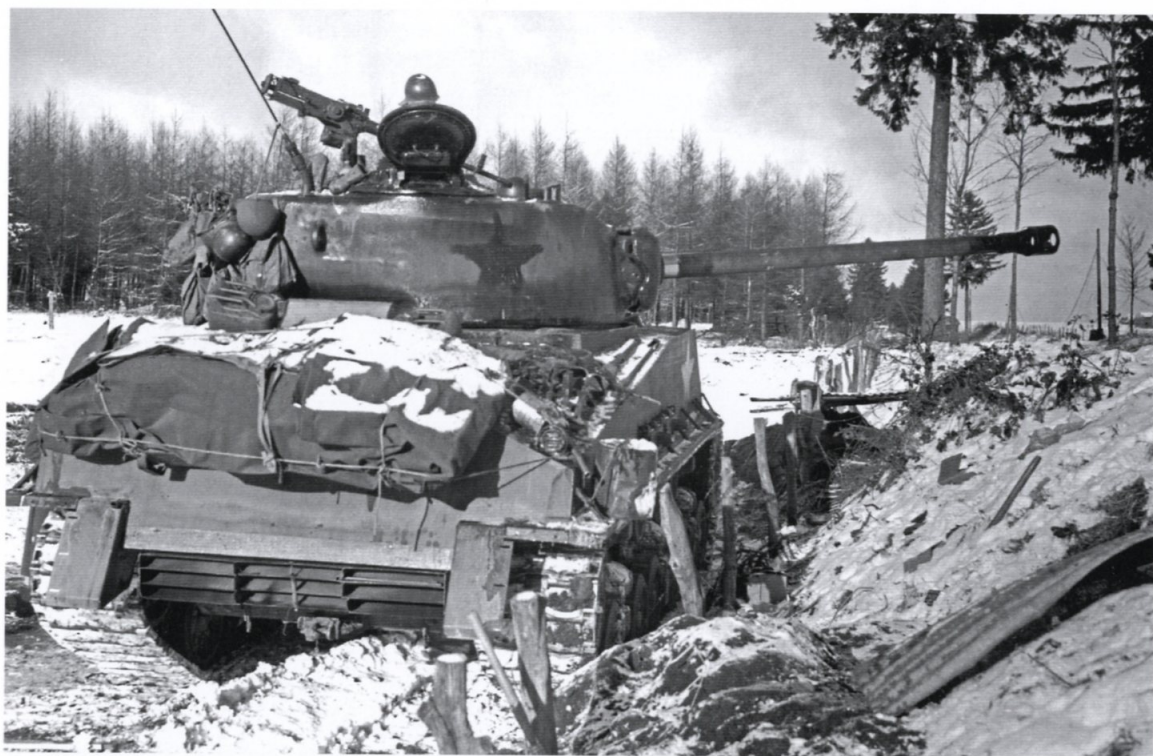
The ultimate solution for the Sherman's flotation problems was the new horizontal volute spring suspension (HVSS) with wider 23in. tracks. The first batch arrived in the Ardennes and was issued to the badly depleted 4th Armored Division, seen here near Bastogne on January 8, 1945. (NARA)

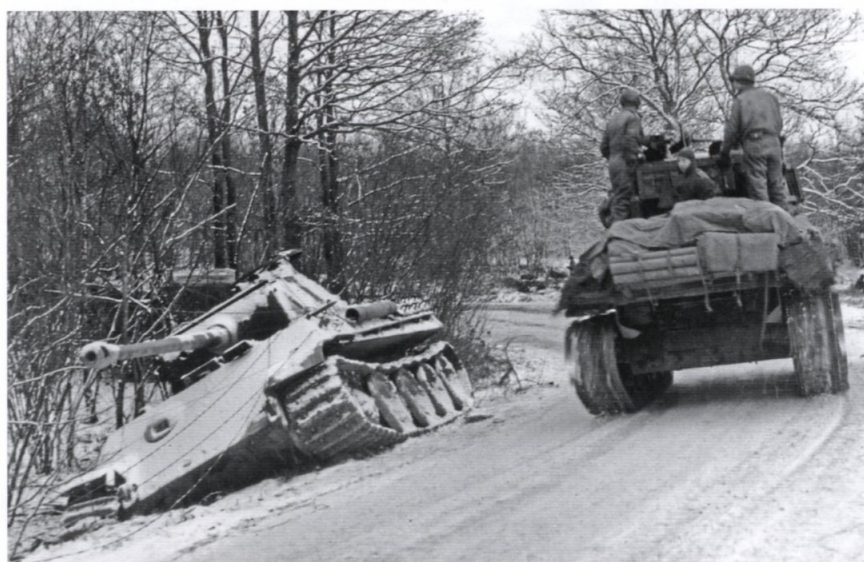
An M4 (76mm) of the 3rd Armored Division passes by an abandoned Panther Ausf. G of the 2nd SS-Panzer Division lost during the fighting near Grandmenil in the days around Christmas 1944. (NARA)

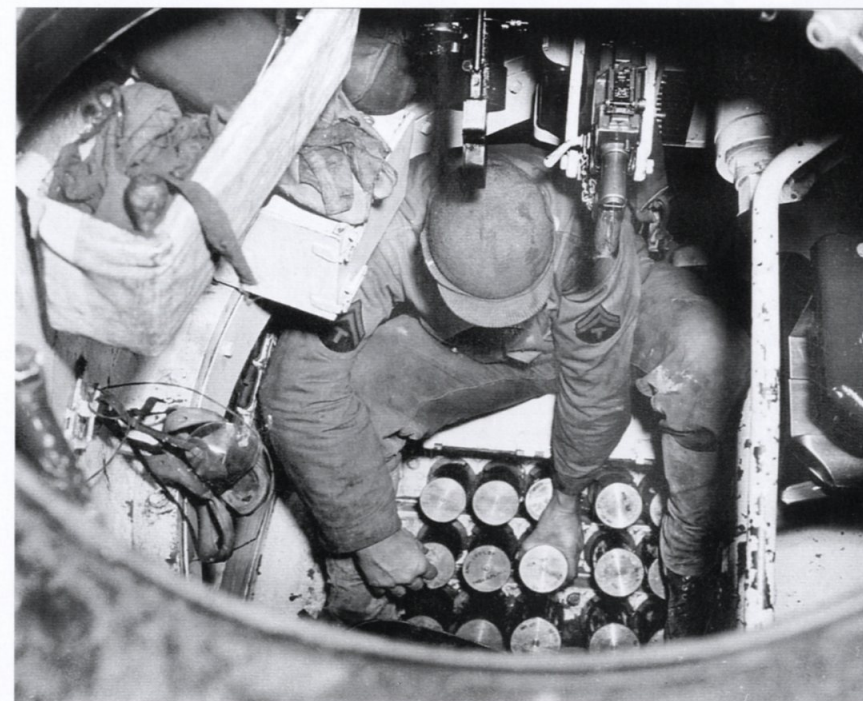
One of the most significant changes on the second-generation Shermans such as the M4A3 (76mm) was the use of wet ammunition stowage, which moved the ammunition from the vulnerable sponsons into a less vulnerable location in the hull floor and encased them in a thinly armored bin. [NARA]

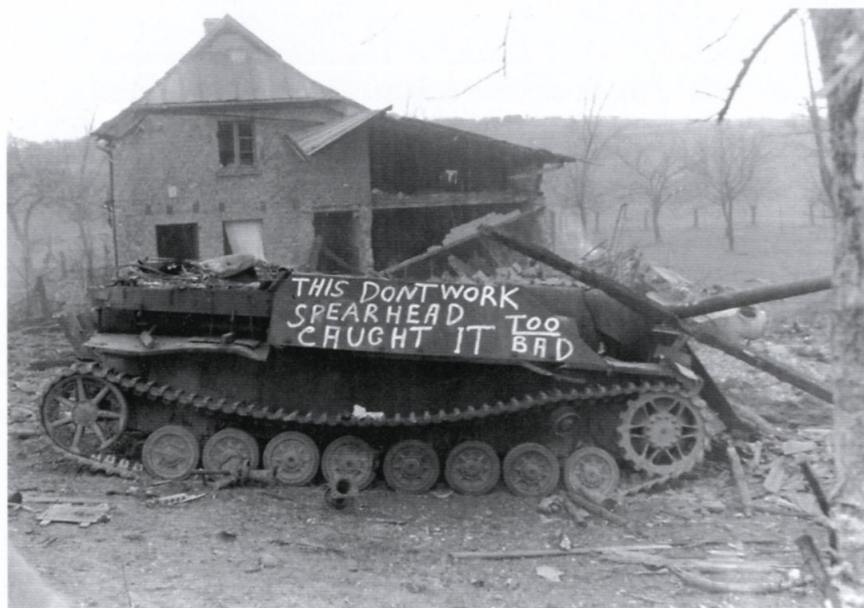
The shortage of Panthers led to substitutions. The low, sleek Jagdpanzer IV was first designed as an expedient tank hunter, combining the Panther's gun and thick armor in a fixed casemate on the PzKpfw IV hull. But in late 1944 and early 1945, some tank battalions began receiving "Guderian's Duck" as a tank substitute under its new designation PzKpfw IV/70 to make up for the continuing shortage of Panthers. As the slogan on the side attests, this one was lost in fighting with the 3rd Armored Division. [NARA]

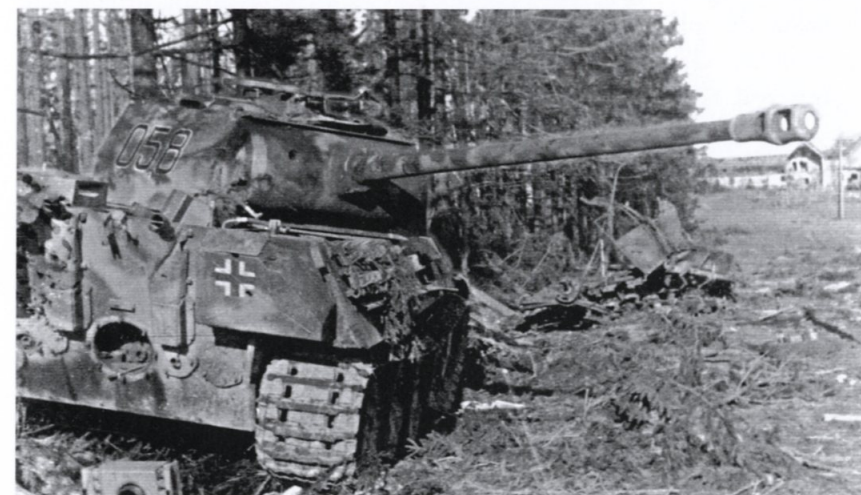
This Panther belonged to the reconnaissance platoon of the SS-Pz.Rgt. 12 headquarters and was knocked out in the outskirts of Krinkelt-Rocherath during the fighting there on December 19. (Bill Auerbach)

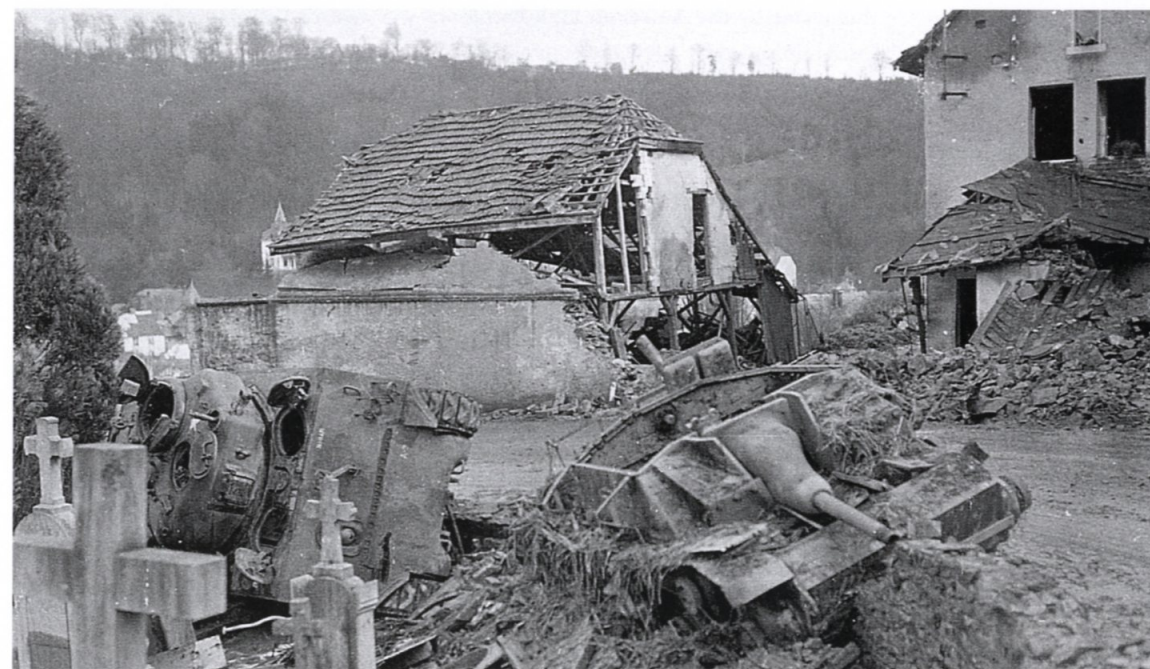
The separate tank battalions supporting the US infantry divisions along the Belgian border were equipped mainly with the 75mm Sherman. The 707th Tank Battalion was attached to the embattled 28th Division, and one of its M4A3 tanks can be seen knocked out behind a StuG III assault gun in the village of Clervaux after the fighting. [NARA]

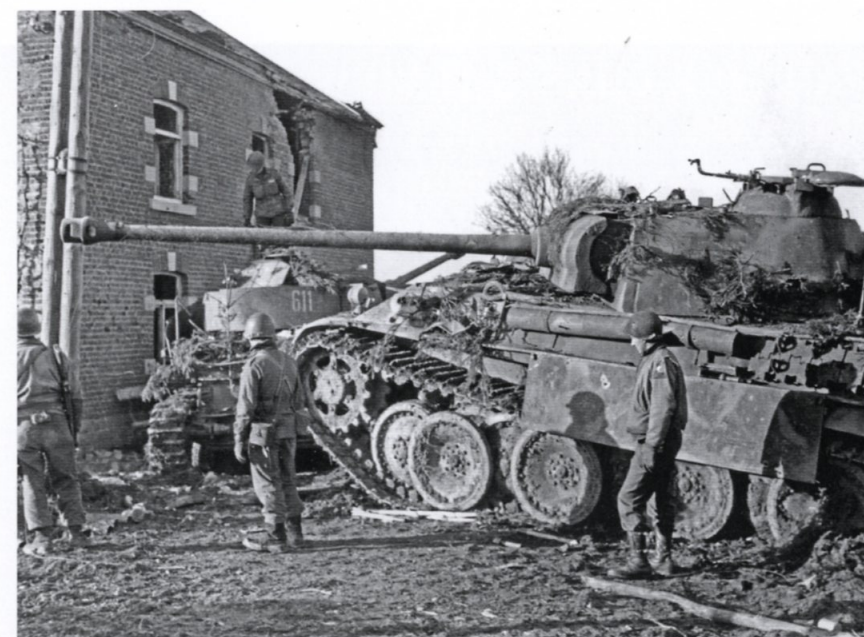
This Panther Ausf. G of the 116th Panzer Division was knocked out by the 3rd Armored Division during the fighting for Hotton on December 26 along with a PzKpfw IV, tactical number 611, in the background. The Panther is a new production tank built no earlier than October 1944, judging from the crew compartment heater cowl on the rear engine deck.

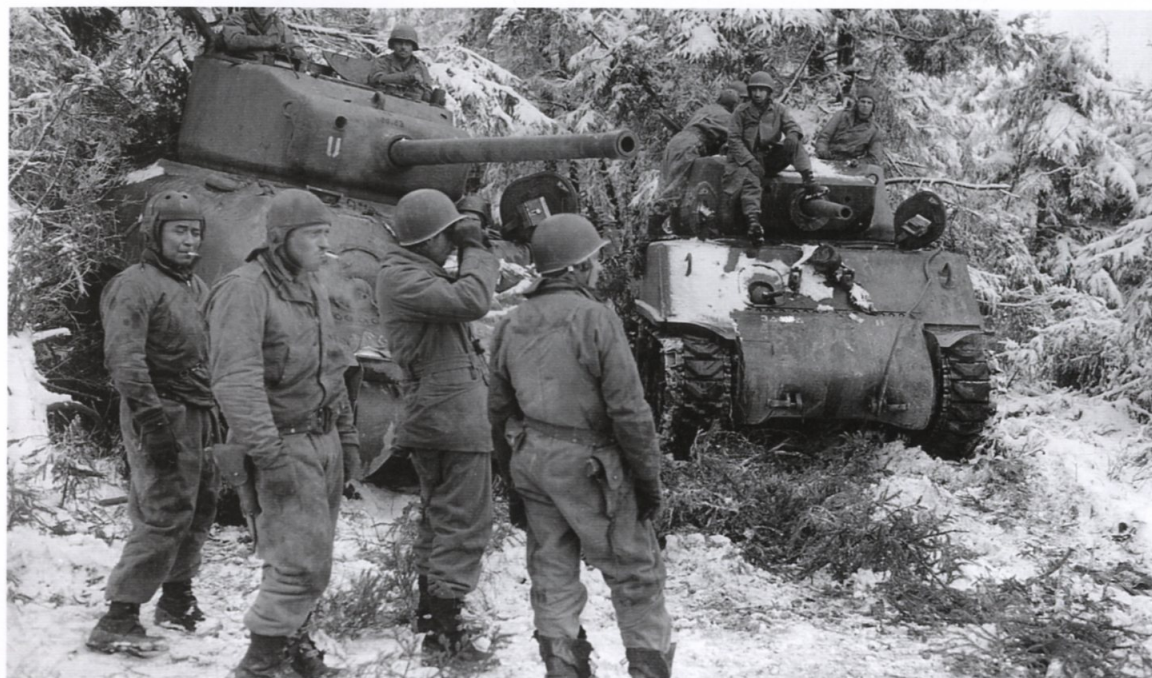
A pair of 3rd Armored Division Shermans in the Ardennes with a veteran M4A1 (76mm) on the left and one of the heavily armored M4A3E2 assault tanks on the right. (NARA)

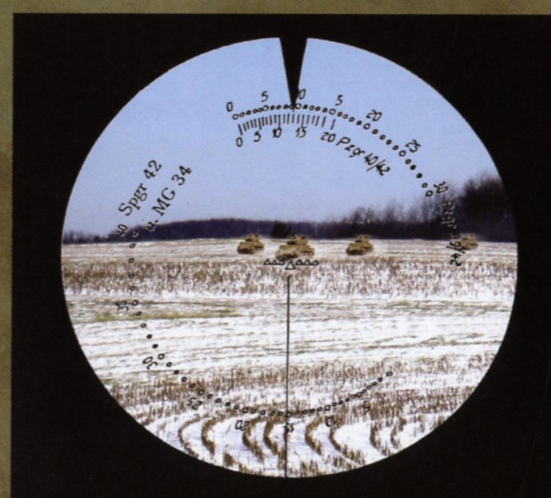
The view through the same gunsight but set at 5 power shows a much clearer view of the enemy tanks.

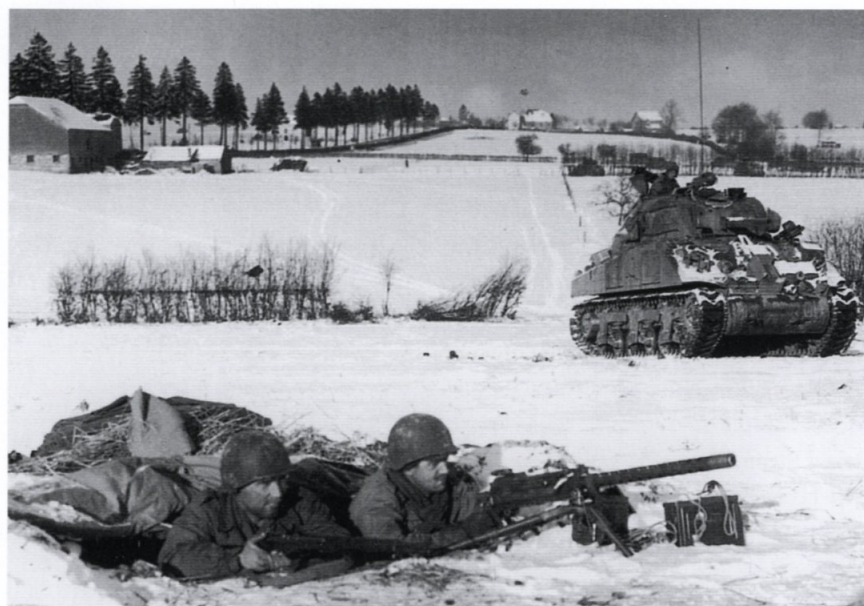
An M4 medium tank of the 4th Armored Division takes part in operations to push out of Bastogne on January 3, 1945. A .30cal machine-gun team is positioned amid the snow in the foreground. [NARA]

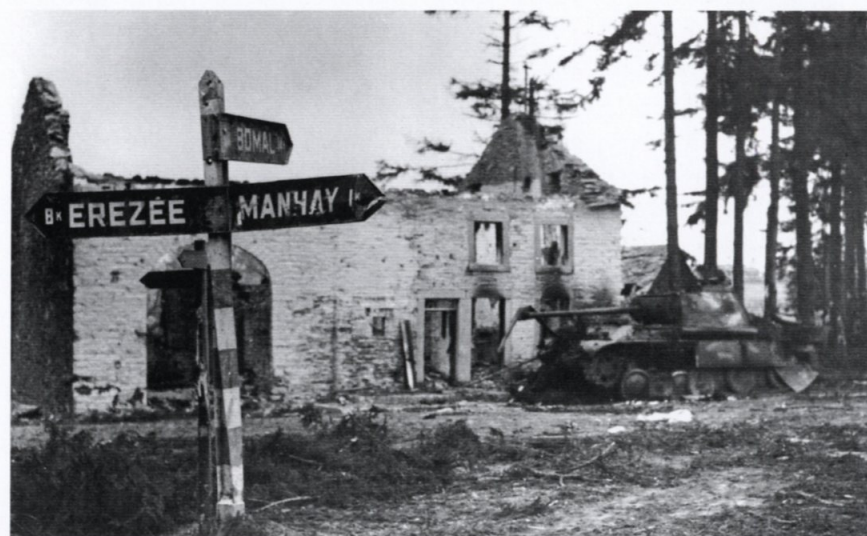
A burned-out Panther Ausf. G of the 2nd SS-Panzer Division lies in a fork in the road between Manhay and Grandmenil after the fighting on Christmas Eve with the 3rd Armored Division. [NARA]

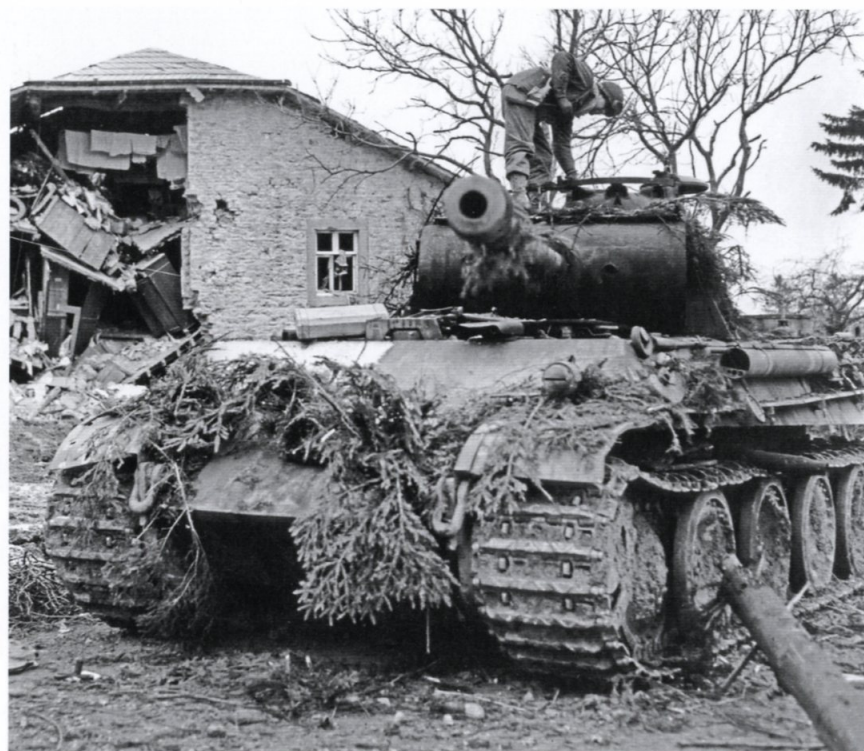
On Christmas Eve, the 2. SS-Panzer Division swept through Manhay and into Grandmenil, pushing aside Task Force Kane from the 3rd Armored Division. This was one of the Das Reich Panthers lost in the fighting and is typical of the configuration of the tanks that fought at Freyneux. [NARA]

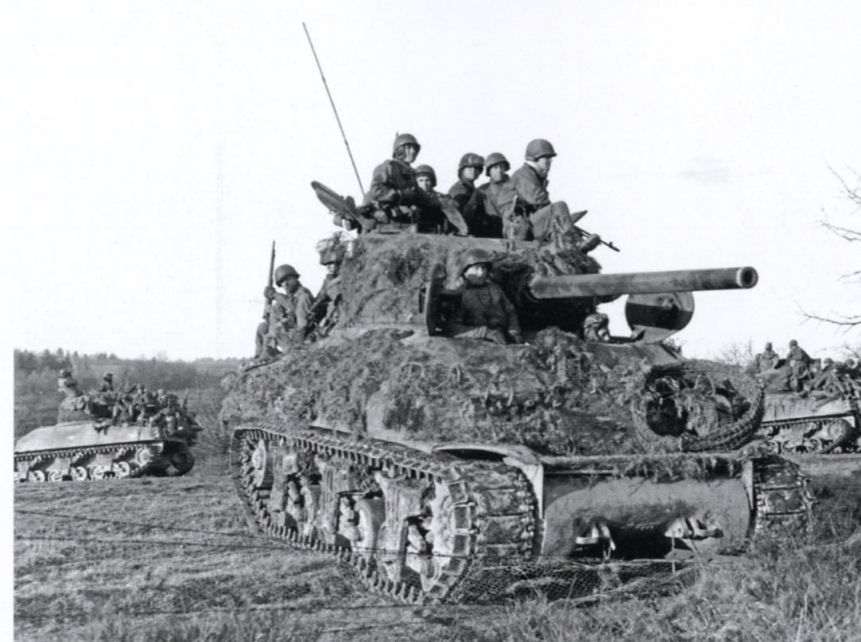
The 2nd Armored Division attacked the exposed flank of 2nd Panzer Division on Christmas. Here a group of M4A1 (76mm) carry infantry into an assault near Frandeux on December 27. [NARA]

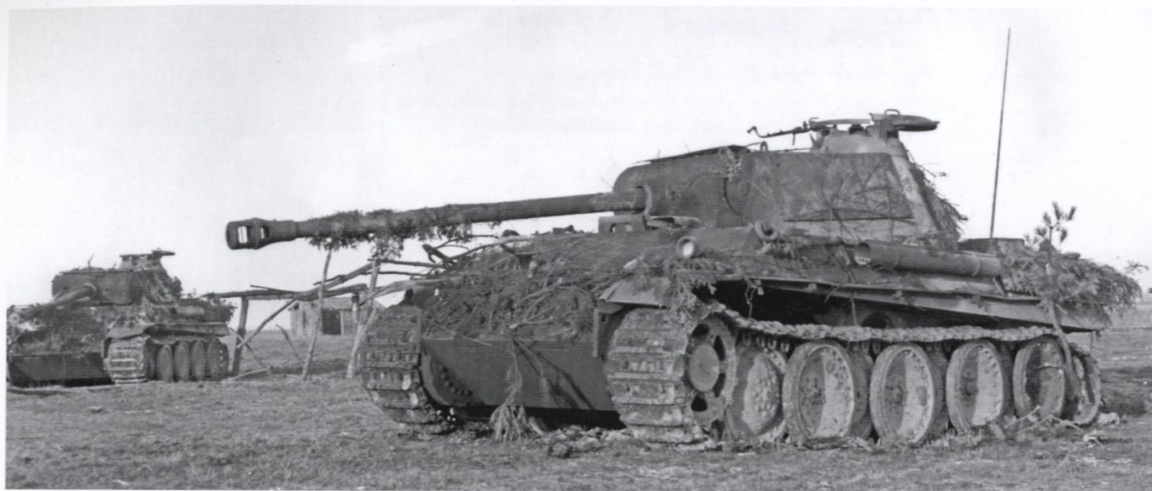
A trio of Panther Ausf. G of Pz.Rgt. 9 lay burned out in a field outside Humain, Belgium, on December 28, 1944, after a battle with the US 2nd Armored Division on December 27. [NARA]

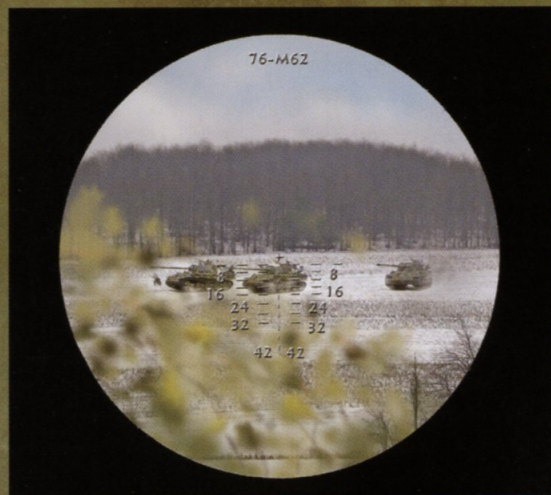
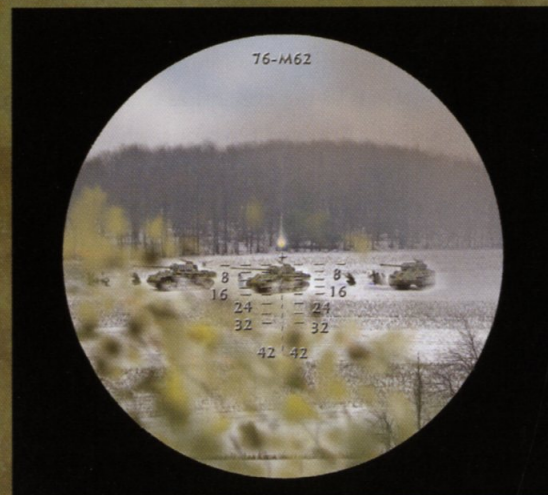
SHERMAN GUNSIGHT VIEW

An approaching Panther tanks, 800 yards away. One of the major problems for gunners was the tendency of the gun to stir up dust and debris.

This is shown here with the tracer from the projectile visible slightly over the Panther. If necessary commands would be called by the commander or neighbouring tanks.

The Sherman's 76mm M1A2 gun was provided with an M71D monocular telescopic sight. The view here shows an engagement at a typical range of 800 yards. Unlike the Panther, the Sherman gunner was provided with a periscopic sight as well which he would use for general observation, switching to the telescopic sight only when engaging a target. The M71D sight had only a single magnification of 5 power, and the gunner had a small switch which enabled the reticle to be illuminated in poor lighting conditions. The reticle had range graduations for the standard M62 armor piercing projectile; the performance of the M42A1 HE projectile was essentially similar at ranges under 1,000 yards. The reticle pattern was graduated in yards, so the commander estimated the range to target, included this in his firing commands, and the gunner adjusted the sight on the target accordingly. The standard commands provided by the tank commander during an engagement were as follows:

In reality, this formal sequence was too time consuming, and more often than not, crews adopted their own simplified commands with a more typical command sequence being simply: "Get that tank over by the barn on the right side of the hill".

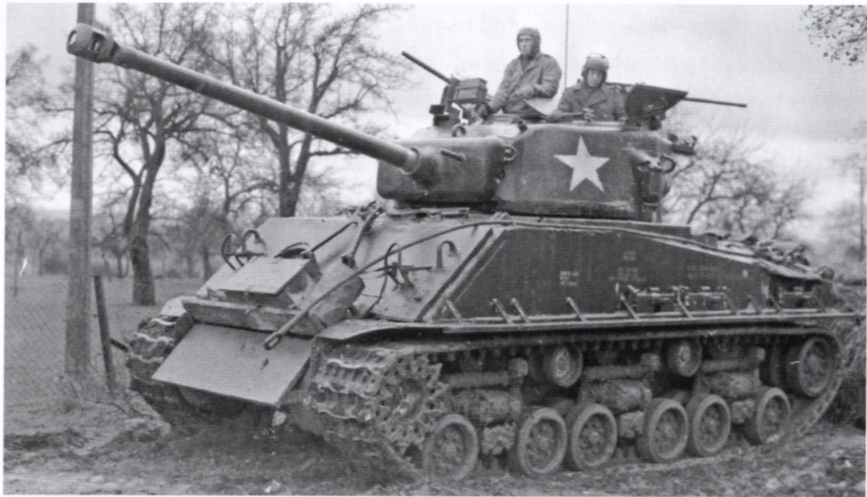
Aggravated by the failure of Ordnance to address the Panther threat, US tank units in ETO took measures into their own hands. The 12th Army Group offered this configuration as their solution to the problem, refitting an M4A3E8 with extra armor plate on the hull front and making a number of other changes such as a coaxial .50cal machine gun and an additional machine gun for the commander. [NARA]

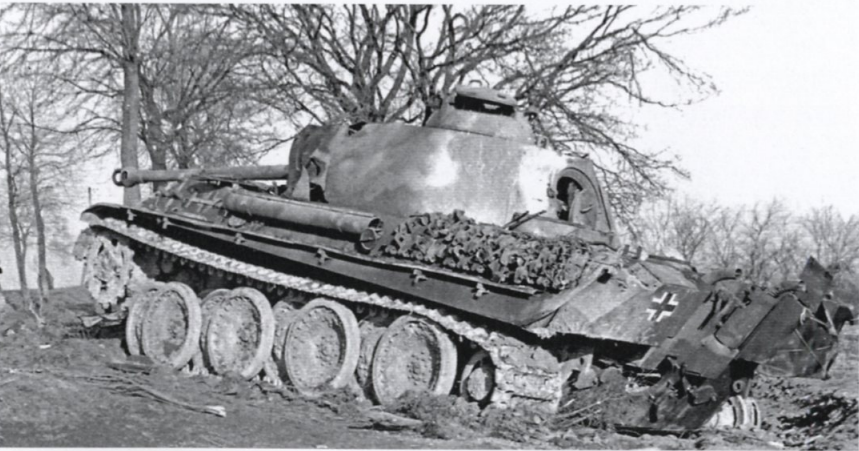
Panther armor plate became increasingly brittle in 1944 as supplies of key alloys disappeared. This Panther Ausf. G is from the Panzer Lehr Division, knocked out during the attacks on Buissonville after Christmas. The two hits on the front turret side caused the plate to break away in large chunks, instead of creating small holes. [NARA]

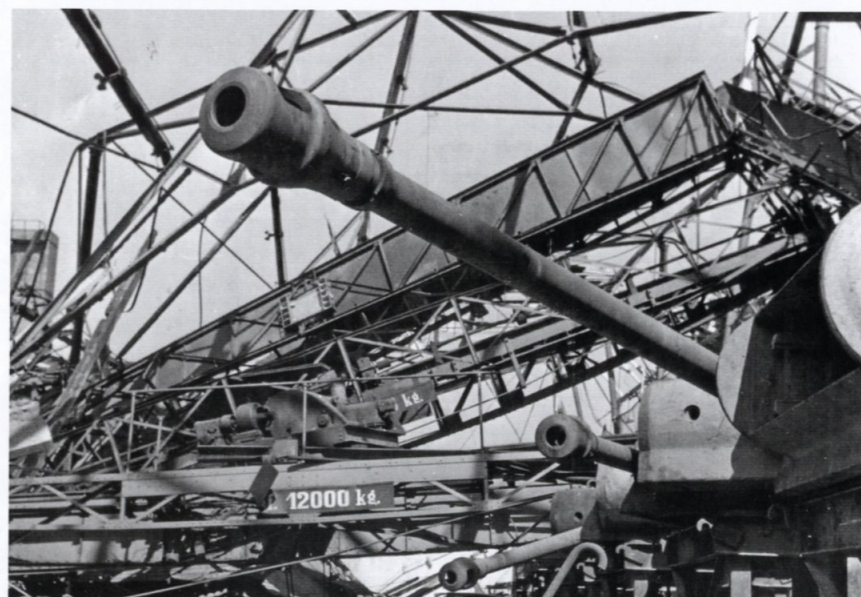
To put an end to the Panther threat, the Allied air forces reinvigorated the bombing campaign against the German tank plants. The MHN plant in Hanover was shut down in March 1945 as its supplies were cut off and its assembly lines repeatedly bombed. [NARA]

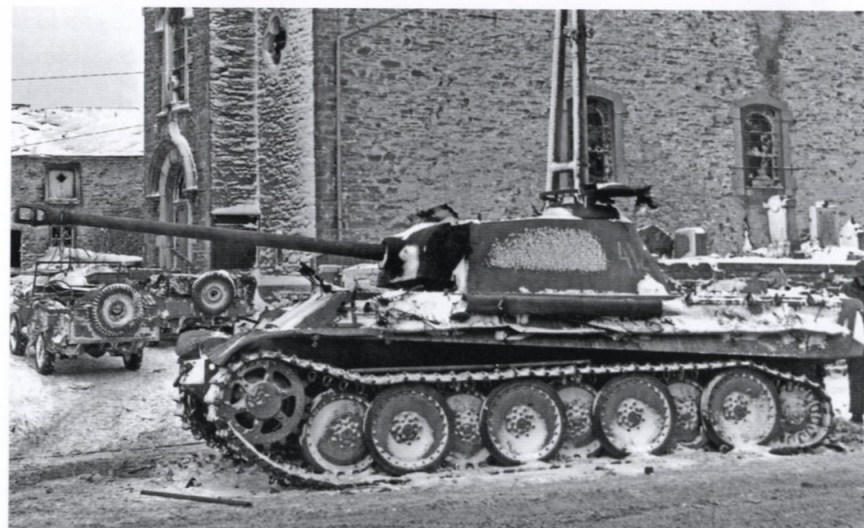
A Panther Ausf. G tank from the 9th SS-Panzer Division, knocked out near the village church in Sterpigny, Belgium, after having been hit in the rear by an M36 90mm GMC of the 703rd Tank Destroyer Battalion during fighting there in the final days of December 1944. [NARA]
